THE BROOKSIDE PROJECT DRAFT FINAL ENVIRONMENTAL IMPACT REPORT (Volume IIA)

**DRAFT FINAL
ENVIRONMENTAL IMPACT REPORT
Volume IIA**

Tree Survey and Arborist Report

THE BROOKSIDE DEVELOPMENT TENTATIVE TRACT NO. 72798
CITY OF WALNUT

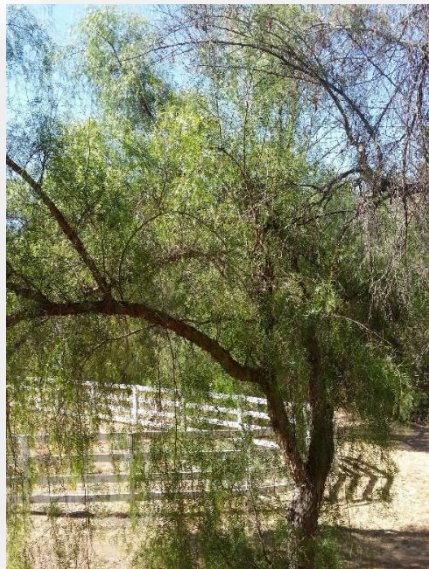
Plate 1. This a view of a young Peruvian pepper with an unbalanced canopy (tree #137).

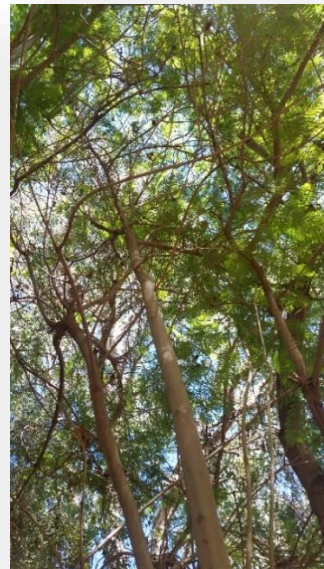
Plate 2. This a view of crowded canopies, a common situation within the project site (tree #329).

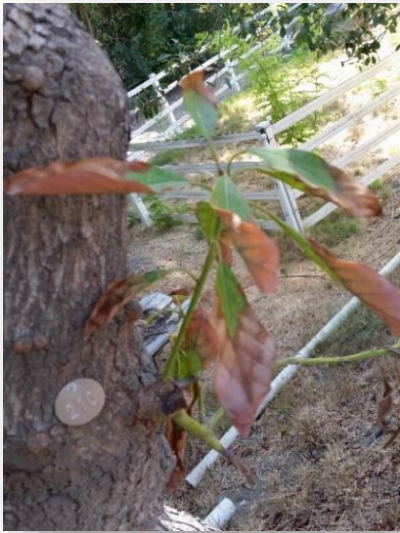
Plate 3. This is a view of leaf tip burn of a shamel ash within the project site.

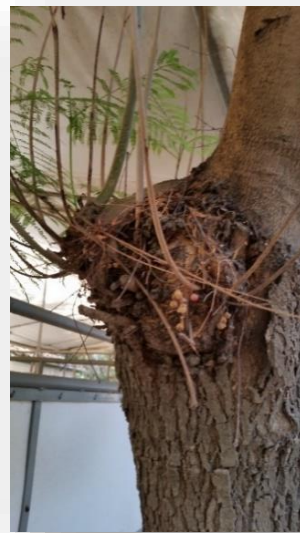
Plate 4. This is a view of an inappropriate cut with resultant water sprouting on Tree 136.

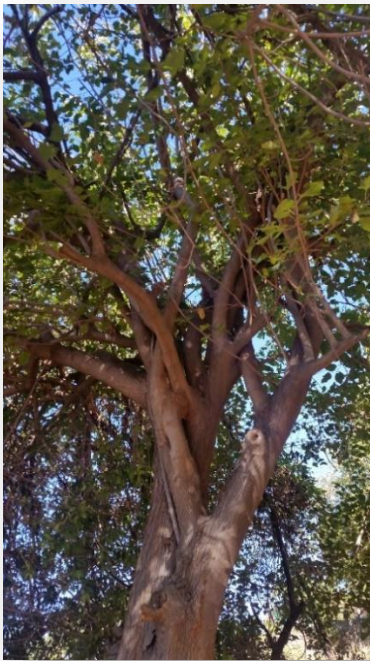
Plate 5. This is a view of poor branch scaffolding within a white mulberry (tree #290).

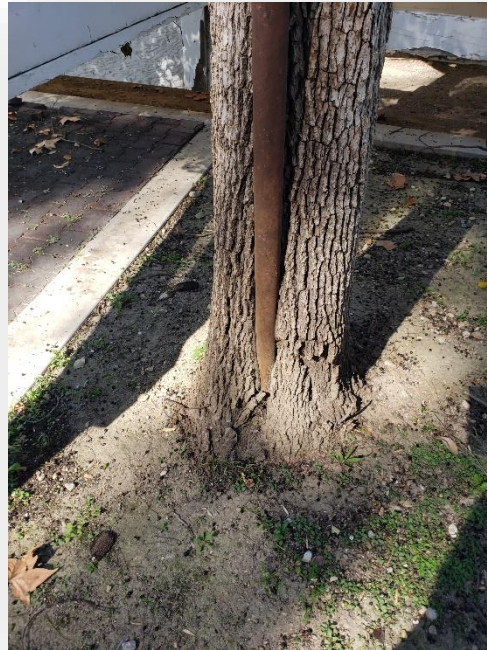
Plate 6. This is a view of an embedded pipe within the stem of a tree (tree #564). *This was taken in February 2020.*

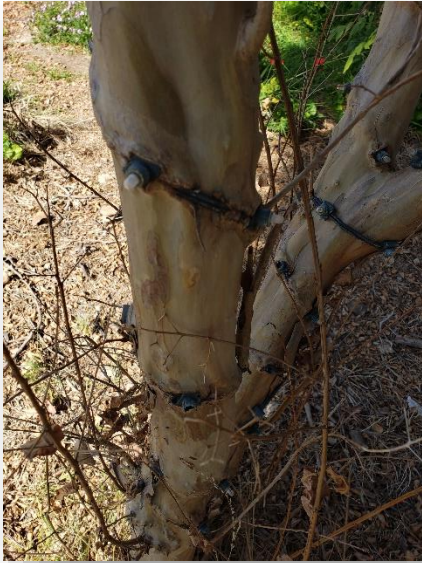
Plate 7. This is a view of an embedded string of ornamental lights girdling a tree (tree #539). *This was taken in February 2020.*

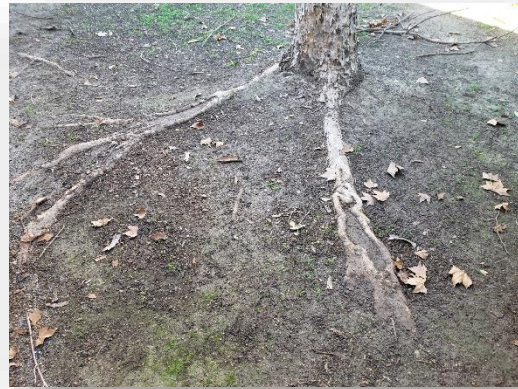
Plate 8. This is a view of surficial roots and compacted soil (tree #520). *This was taken in February 2020.*

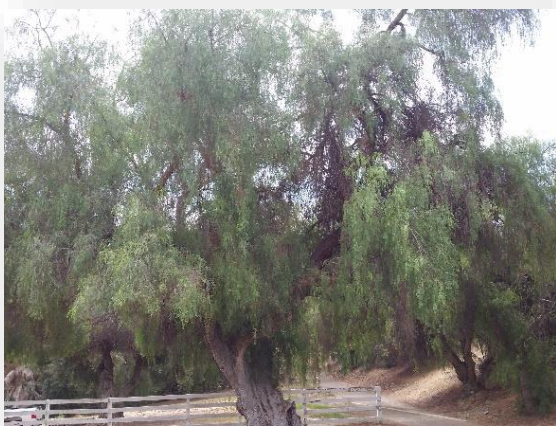
Plate 9. This is a view of a senescent Peruvian pepper within the project site (tree #229).

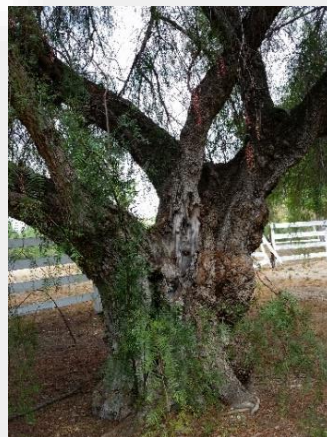
Plate10. This is a view of a Peruvian pepper with a hollowed stem and burls at its base (tree #221).

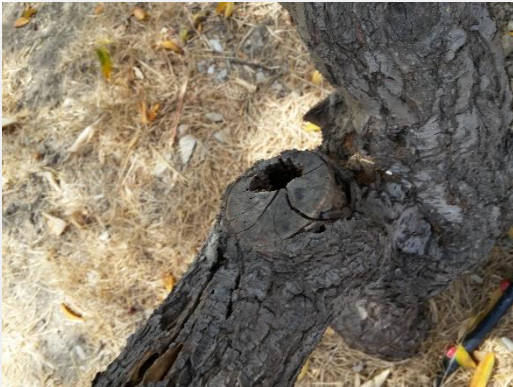
Plate 11. This is a view of termite damage localized in an open branch cut of a fruit tree onsite (tree #214).

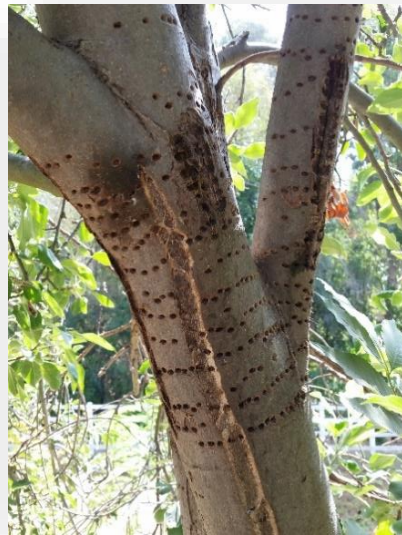
Plate 12. This is a view of sapsucker damage penetrating much of the cambial layer of the tree (tree # 216).

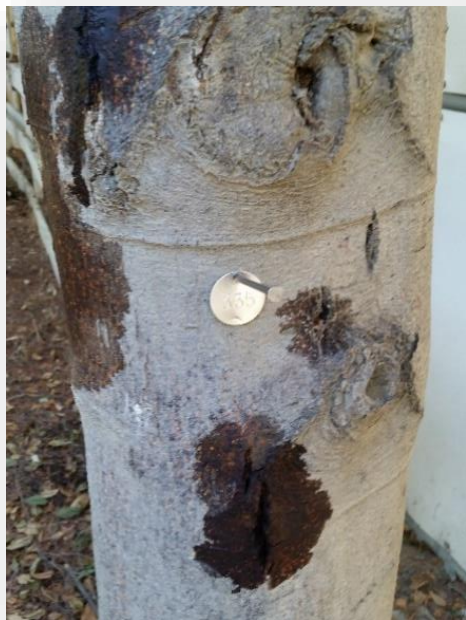
Plate 13. This is a view of stained wood of a white alder typically associated with a borer (tree # 335).

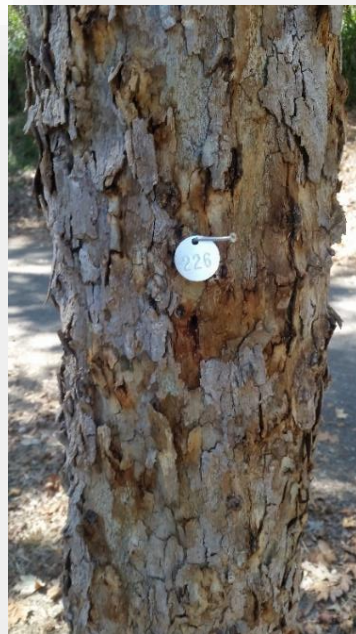
Plate 14. This is a view of stained wood of a western sycamore typically associated with a PSGB borer (tree # 226).

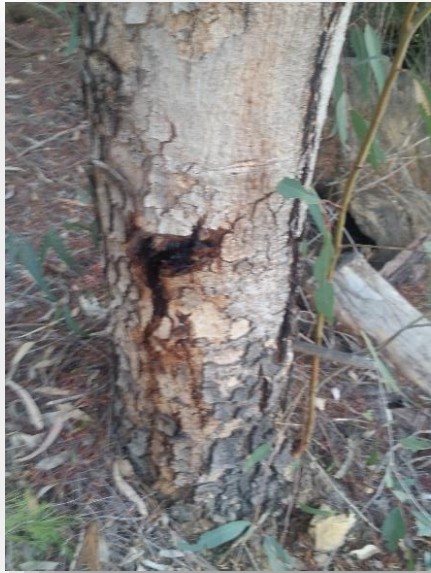
Plate 15. This is a view of an exuding canker on Tree 172.

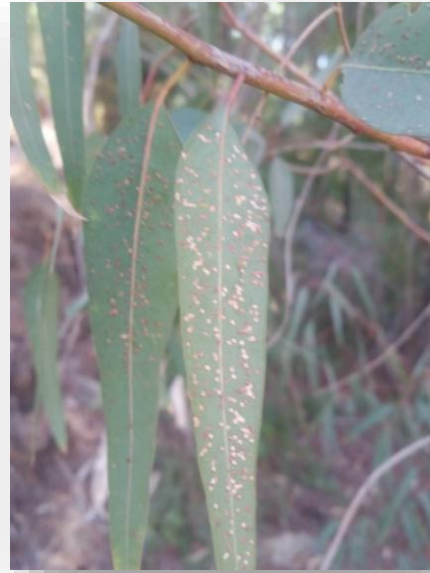
Plate 16. This is a view of infected eucalyptus foliage, possibly lerp psyllid.

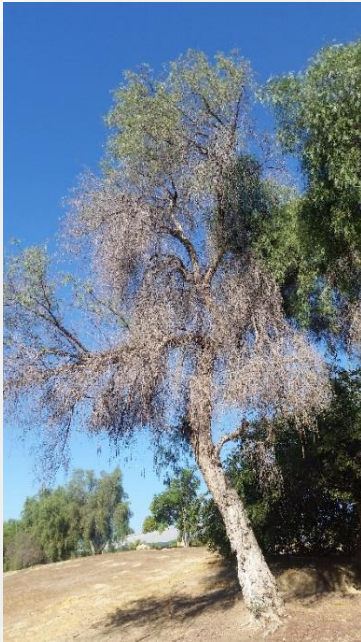
Plate 17. This is a view of significant canopy dieback of a tree competing with the canopy of another.

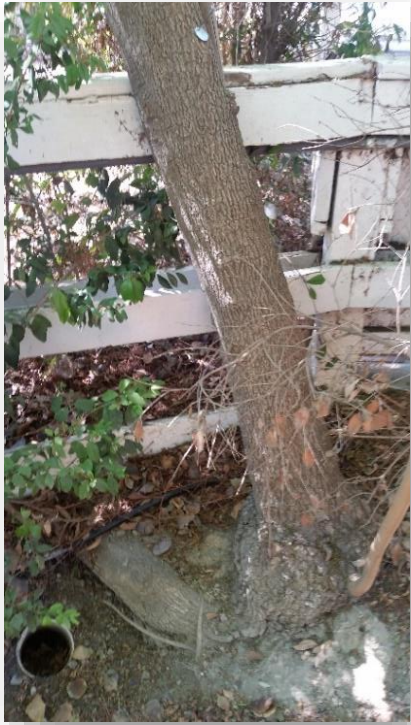
Because of the prolonged lack of maintenance, several trees within the site pose a significant threat of failure. These trees may show signs of stem cracking, significant lean (or have fallen), serious decay, or are simply dead. Trees showing indication for immediate removal include the following individuals:

Plate 18. This is a view of a jacaranda tree slowly falling. Poor flare and root development are noted (tree #328).

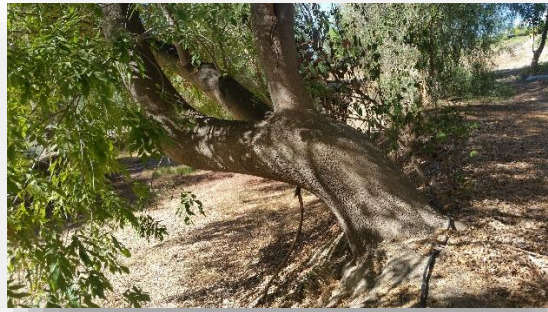
Plate 19. This is a view of a shamel ash slowly falling due to a grade change (tree #294).

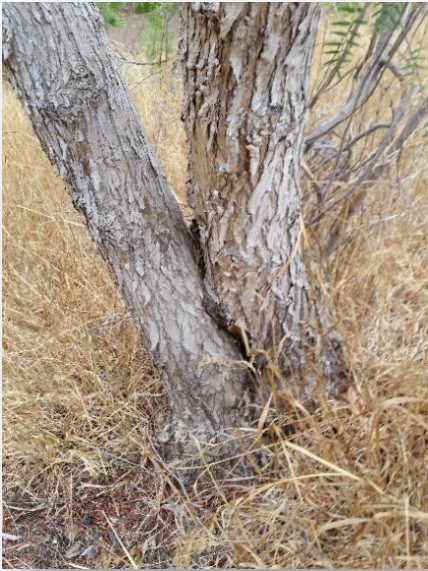
Photoplate 20. This a view of a Peruvian pepper with codominant stems and included bark (tree #142).

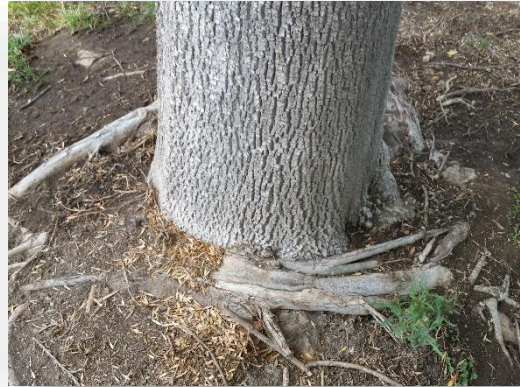
Photoplate 21. This a view of a large shamell ash with partially girdling roots (tree #194).

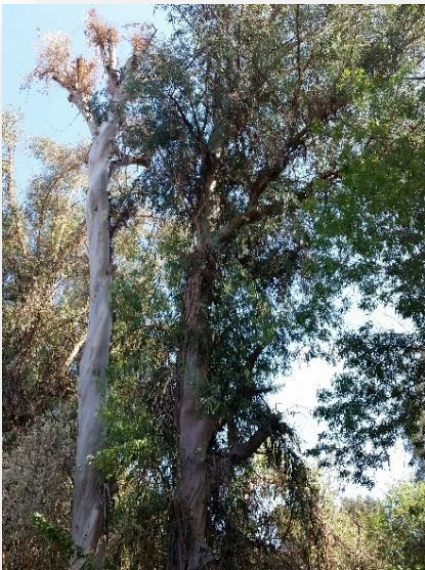
Plate 22. This a view of a dead blue gum (tree #188).

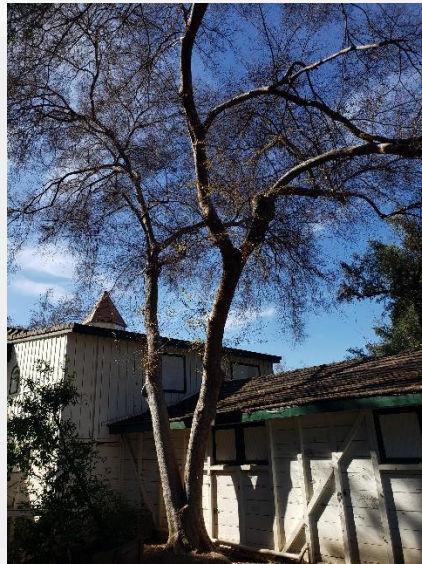
Plate 23. This a view of a dead blue gum (tree #542). *This was taken in February 2020.*
